Mangroves and Estuarine Ecologies

Part C

Mangroves in the Kaipara Harbour

Changes over Time

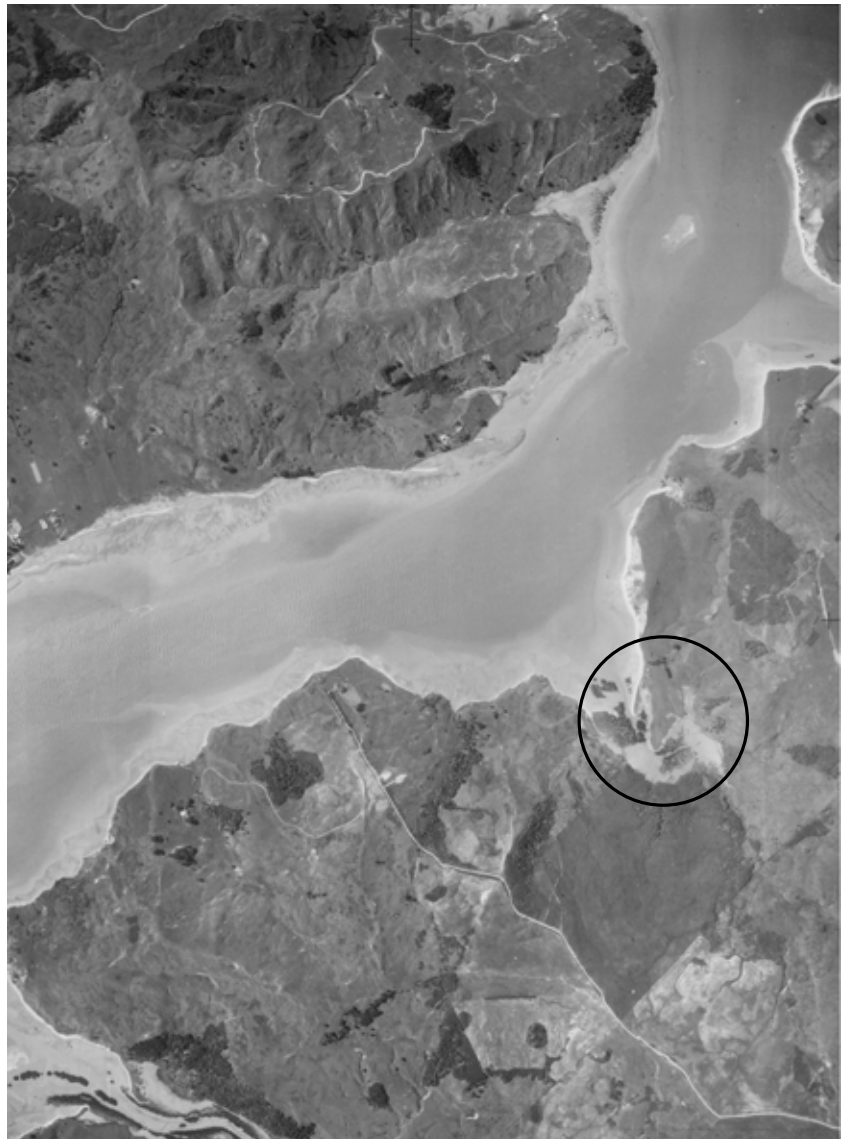
Aerial Photo – Oct 1953

This shows the river in this area with very few mangrove beds.

The estuary which edges my own property is centre right. (Circled.)

The land is almost all cleared although there are significant areas of re-growth. My own property is covered with re-growth bush and a sandy area clear of mangroves lies at the bottom of the section.

The edges of the northern slopes are clear of mangroves and the land is pasture to the water's edge.

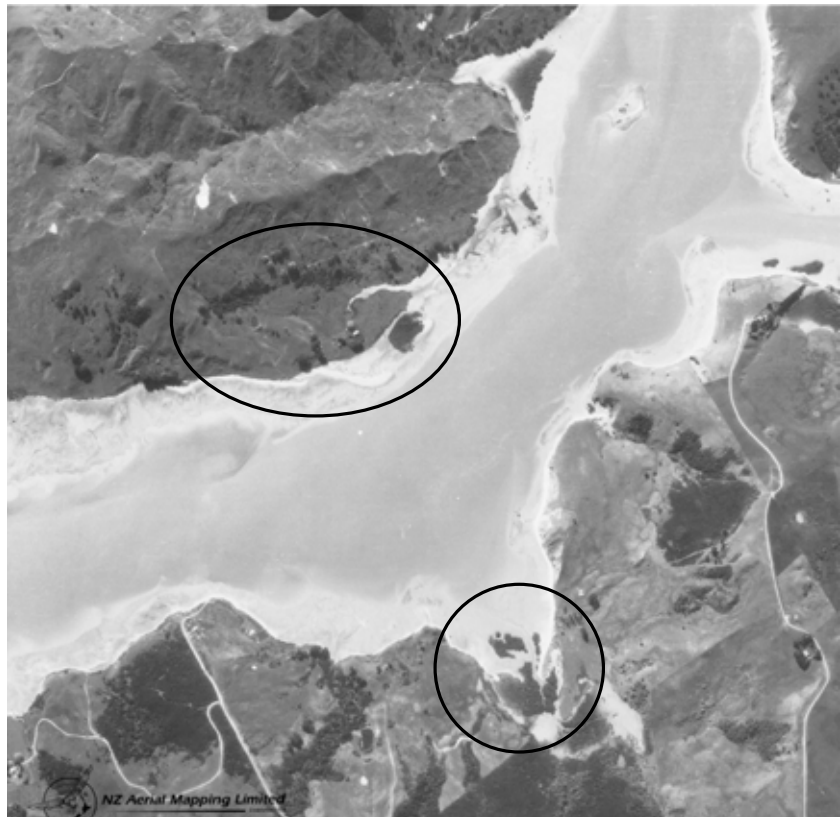
The Otamatea River... Aerial Photo – September 1982

This photo shows mangroves beginning to grow within the river channel, even though exposed to strong winds. (Circled area centre north.)

There are still few if any mangroves on the edge of the Southern slopes of the peninsula to the North. The clear sand area (circled) at the bottom of my own property remains mangrove free.

Aerial topdressing began in 1949, but appears to have had no effect on this area.

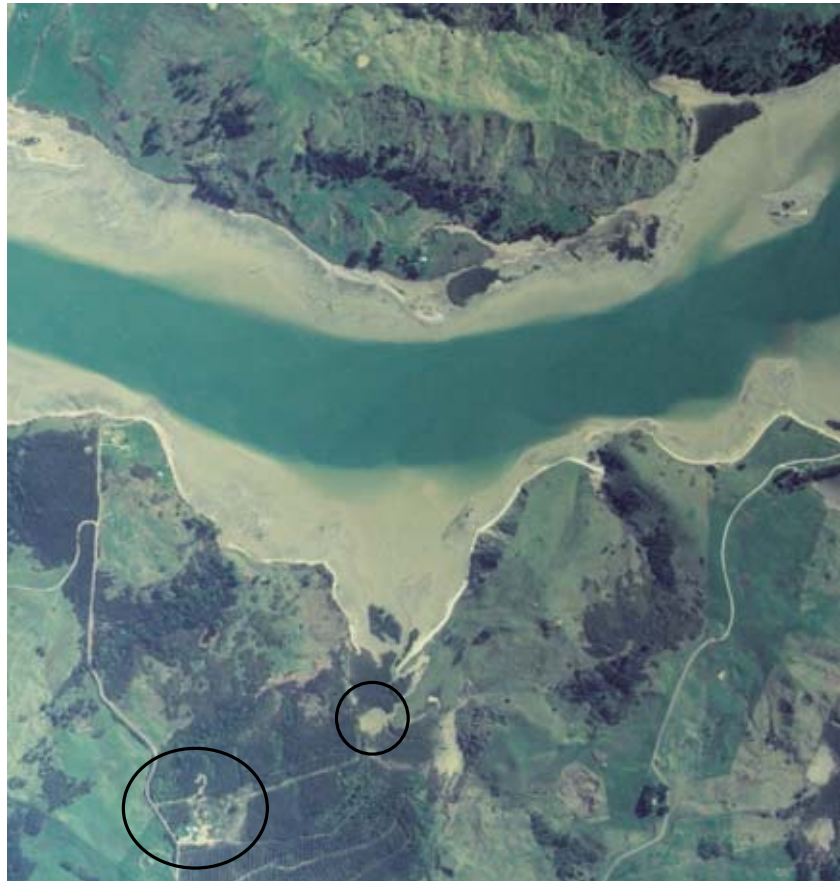
The Otamatea River... Aerial Photo – July 1993.

A house site has been cleared on what is now my property (left circle) but regrowth re-mains on most of the property and the clear sand area (circled) remains clear of mangroves.

Notice that the mangrove beds which do exist are all separated from the pastures by channels making them inaccessible to cattle.

Mangroves continue to extend their beds on the north slopes of the river even though regrowth proceeds to reduce runoff from the pastures on the higher slopes behind.

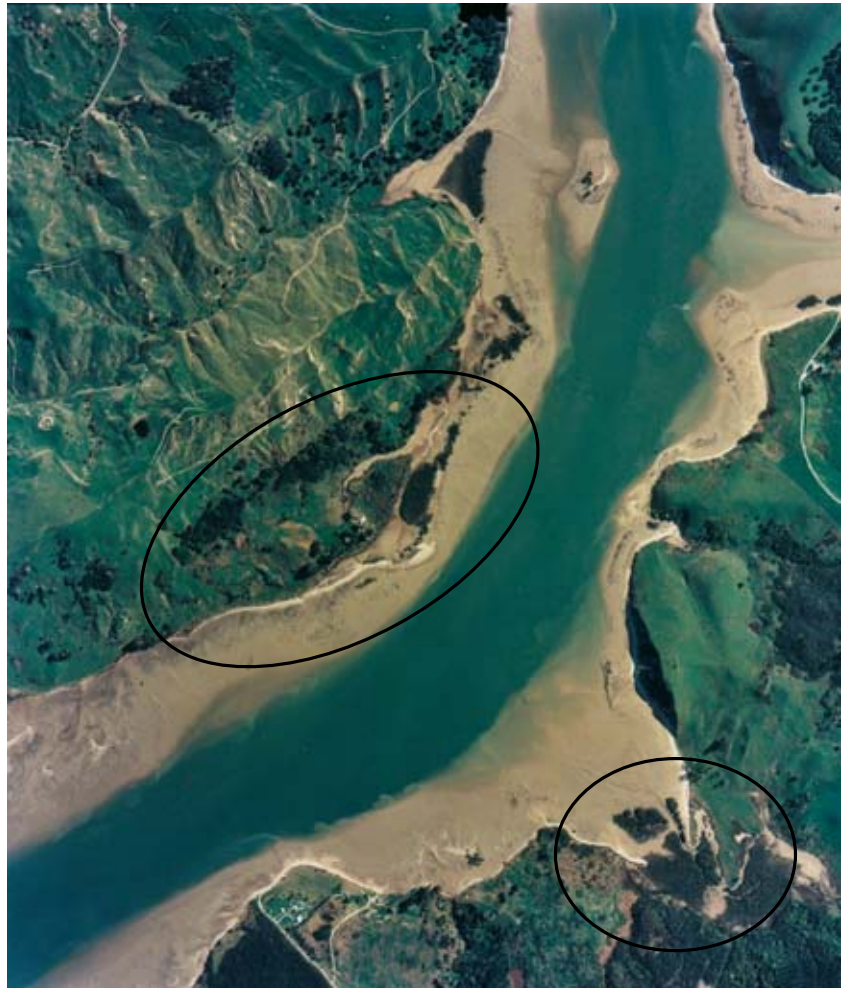
The Otamatea River... Aerial Photo – 2000.

Notice substantial regrowth (circled) on Southern slopes on the Northern edges of the river. If the run-off theory is correct we would expect there would be no mangrove invasion of this area because such regrowth inhibits run-off. But notice the beds starting to establish and these are now (four years later) a continuous stretch of man-groves. Notice too the mangroves beginning to invade the clear area at the bottom of my own property and moving up the estuary. Pasture has turned into regrowth and scrub on properties around my own. (Lower circle). The cattle have gone from this side of the bay.

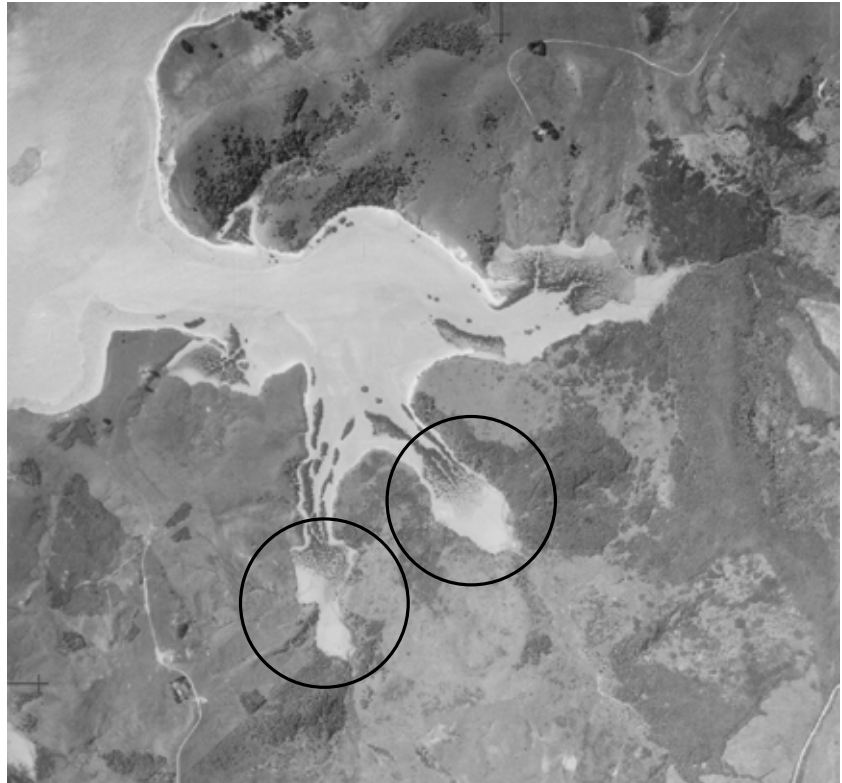
Aerial Photo – 1953

There are few mangroves in the bay before the building of the causeway and dam.

Some mangroves are moving into the estuaries but clear areas at inland ends re-main. (Circled areas).

Sometimes mangroves move from the top of an estuary down towards the sea but this invasion from the harbour or river up to the head of the estuary is much more common.

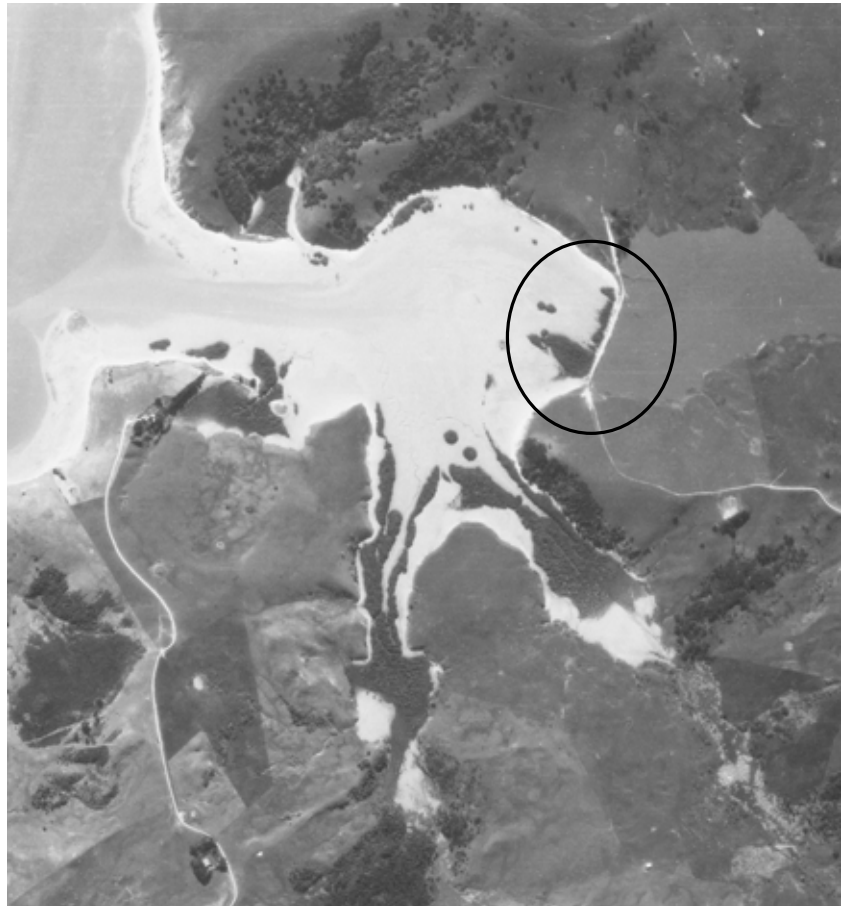
Takahoa Bay ... Aerial Photo – Sept 1982.

A causeway has been built and has formed a large lake behind it. (Circled) Already the mangroves have invaded the bank to the immediate harbour side of the causeway. No cattle are farmed around the two estuaries heading South towards the bottom of the picture and mangroves are filling these areas rapidly. Regrowth on the cliff edges and channels protect the mangroves from any live-stock which remain on the slopes to the East

and West. The same regrowth is presumably reducing sediment run-off and yet the mangroves thrive. Cattle graze the peninsula in the lower middle of the picture.

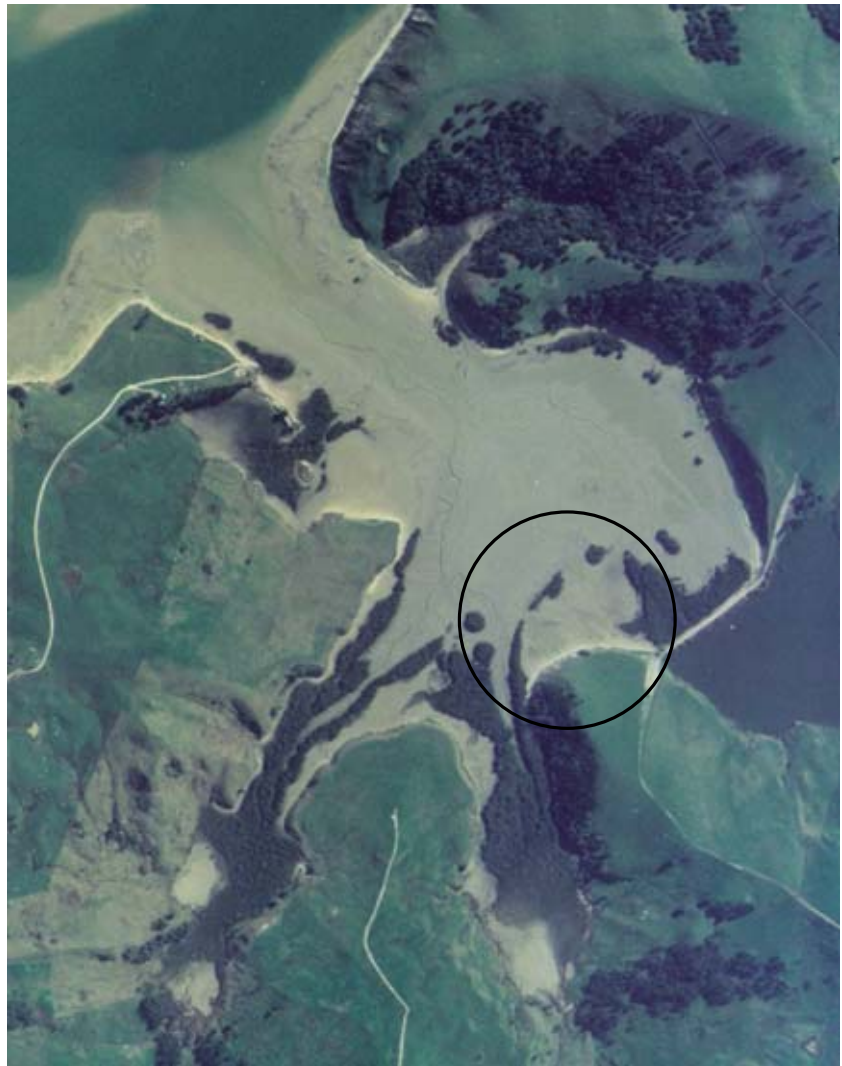
Takahoa Bay ... Aerial Photo – July 1993

The ‘Causeway effect’ is highly noticeable as man-groves form a crescent across the top of the bay and the lack of flushing encourages growth around and along the edges. Channels, cliffs and regrowth continue to protect mangroves invading the estuaries from control by cattle. The circled area demonstrates the classic “encirclement” or “flanking” of a shallow area by mangroves which no longer have to deal with flushing from water behind the dam. Cattle still graze the point

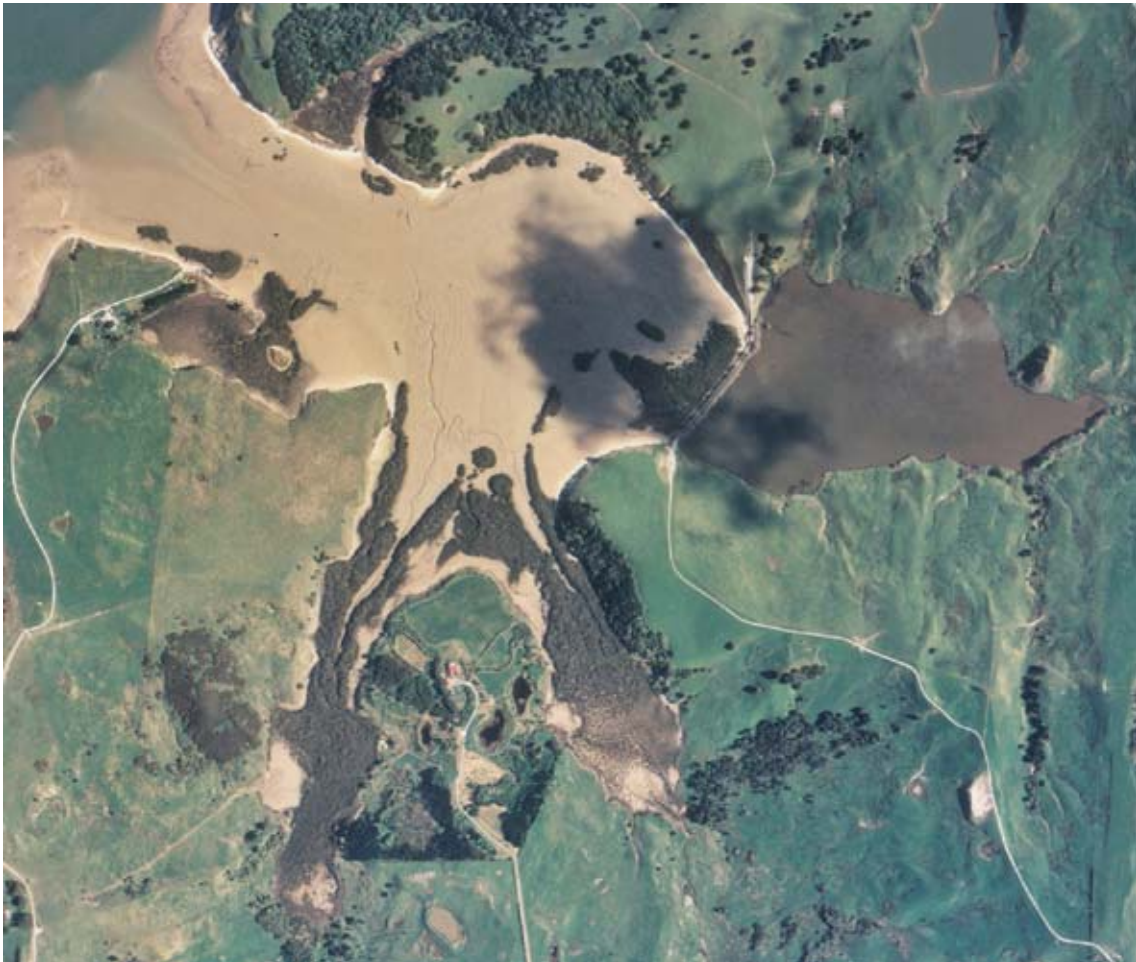
Takahoa Bay... Aerial Photo – October 2000

The southern area of the bay is no longer farmed with livestock at all and the mangroves continue to invade the two estuaries. The owners of the peninsula in the centre of the photo have planted some two hundred thousand trees on the property so there should be much less sediment and nutrient run-off from this land. Yet the mangroves thrive. A recent inspection reveals that mangroves are now invading the area inside the ‘flanking’ line of the previous photo. The owners witness a rapid decline in their mullet catch.

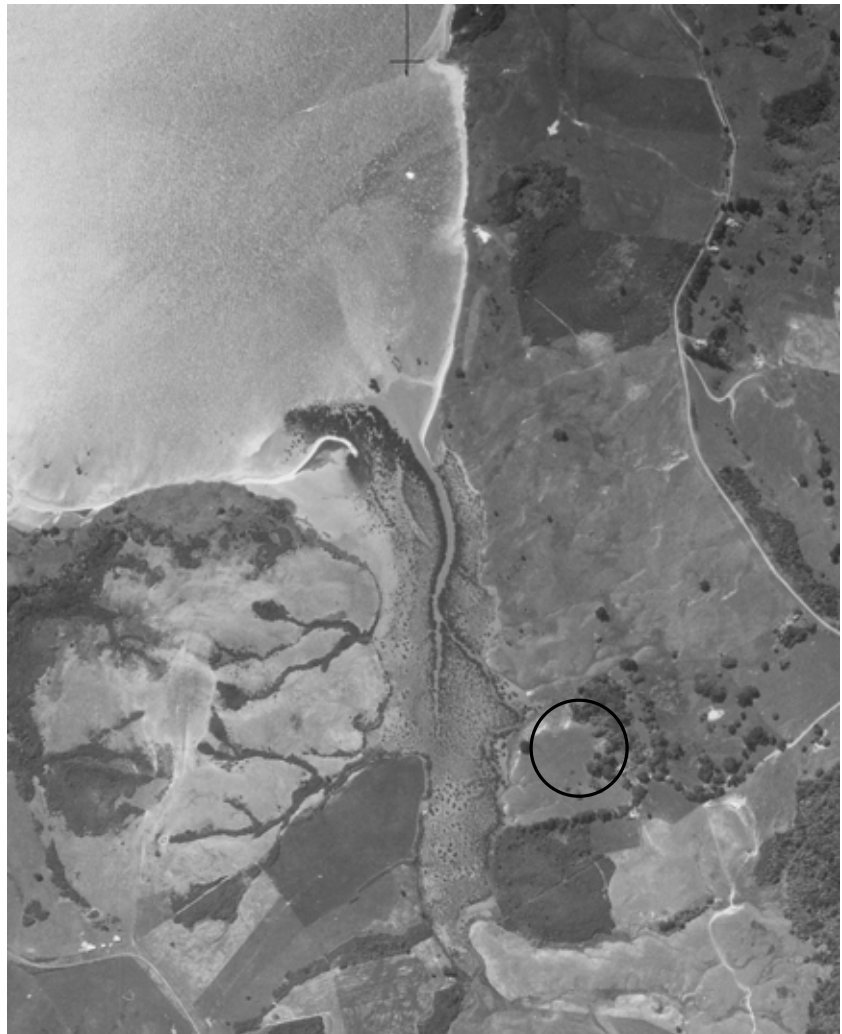
Aerial Photo – October 1953

The historic Minniesdale House is located in the area circled. Early drawings show that schooners used to sail up the creek to service the property. By the fifties the mangroves are starting to invade this creek. The long white beach to the north (Sandy Beach) is free of mangroves.

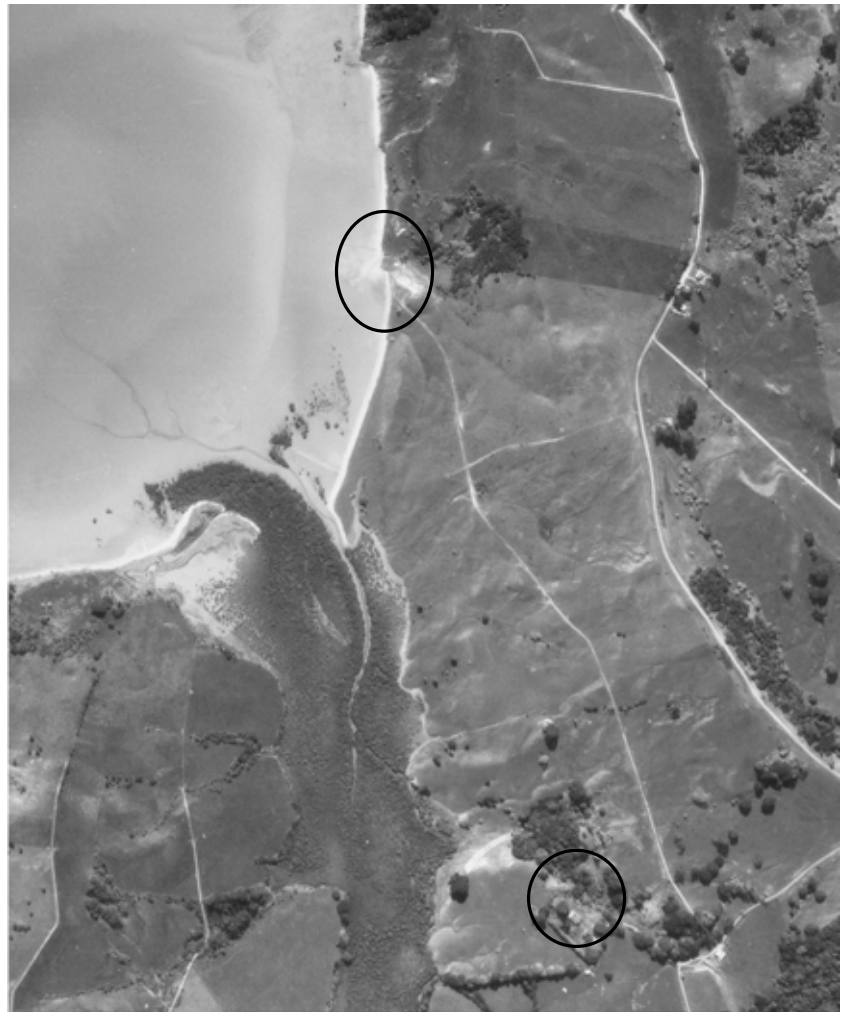
Takapau Creek – Minniesdale House ... Aerial Photo – September 1982

Mangroves are rapidly invading the creek and re-growth is re-placing pasture along the edges of the creek on the left. The circled Minniesdale house is no longer accessible by the estuary channel. The mangroves are beginning to move along the front of the beach. Note small limestone pan half way along the beach. (Circled)

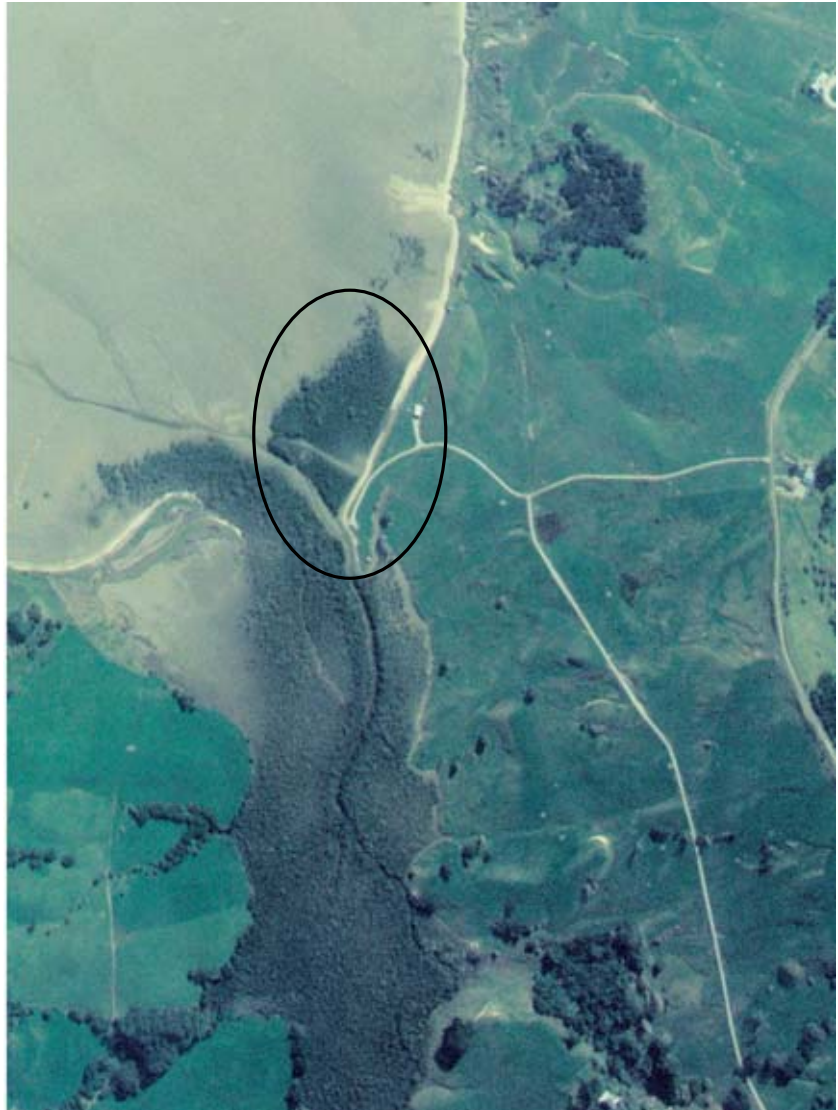
Takapau Creek – Minniesdale House... Aerial Photo – July 1993.

The invasion of the creek is complete and the circled mangroves are now beginning their “march” along the sandy beach. The pan is more visible. But the inhabitants of this bay are about to lose what made it so attractive to the first settlers who built Minniesdale House and developed the home-stead. The present owners are not allowed to do anything to stop this ongoing degradation of their environment, their amenities and their heritage.

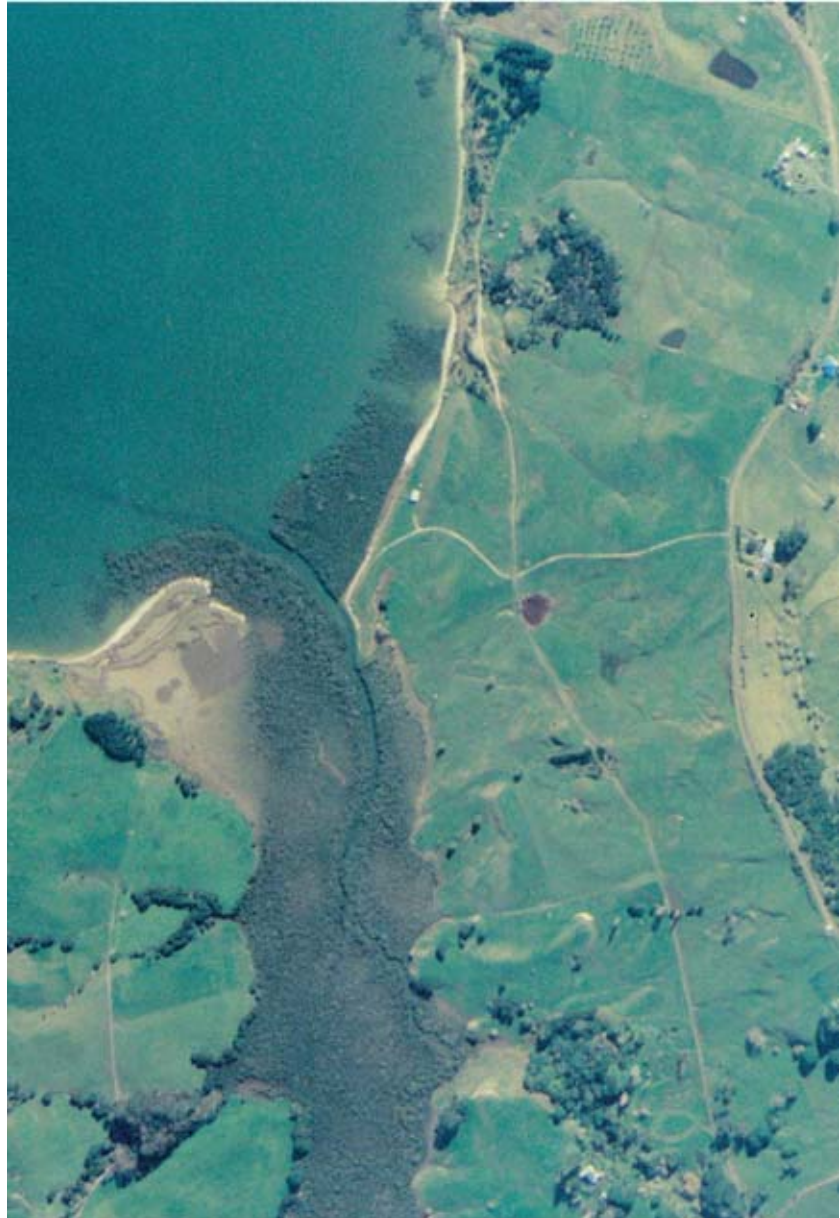
Takapau Creek – Minniesdale House... Aerial Photo – July 1999

The creek is packed with mangroves; just a narrow ditch remains of the early “harbour.” The mangroves have marched past the small limestone pan and are about to move on to the end of the bay. The white sand beach behind the mangroves on the South of the pan has now (2004) disappeared.

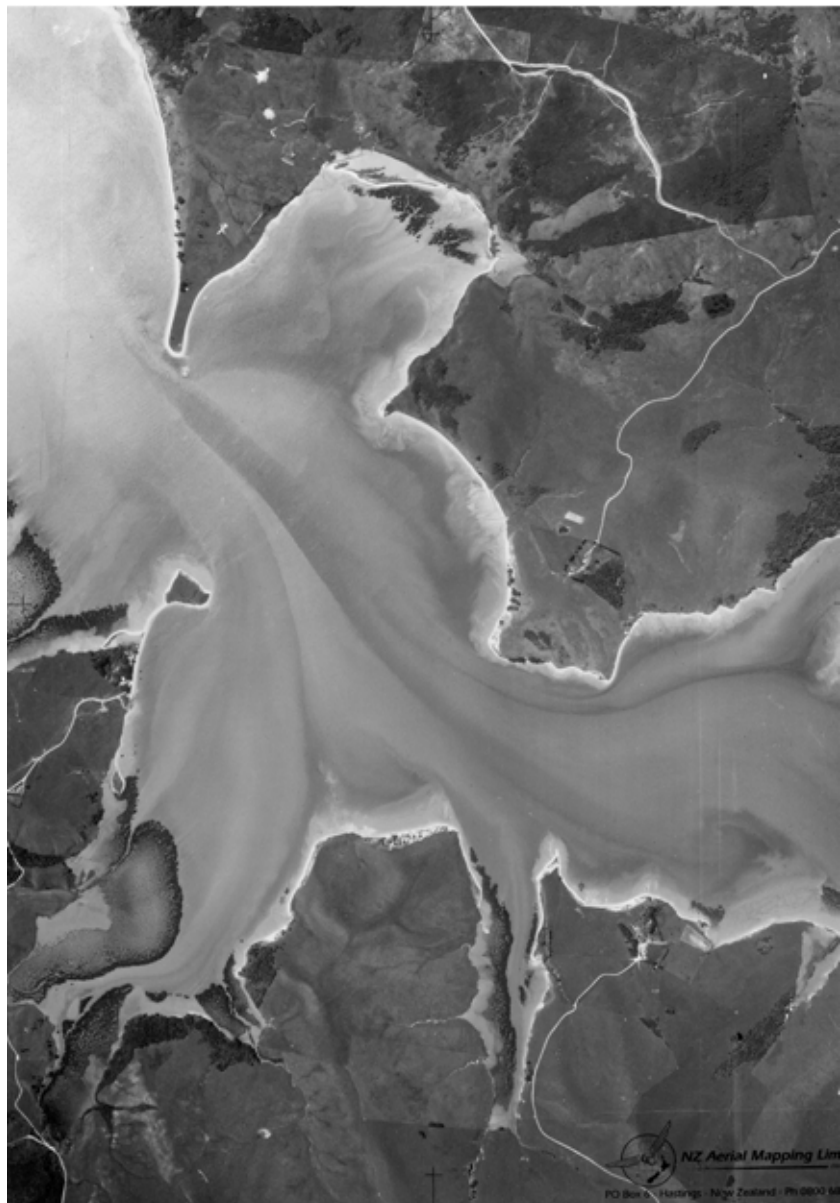
Aerial Photo – October 1953

This area is notable for its lack of mangrove invasion. The original 'Oneriri' farm on the southern side of the river was notable for being almost an island and requiring only a short length of fence to secure the boundaries – the rest of the boundaries were the water's edge and cattle have been free to feed on mangroves. The few isolated clumps are protected from cattle by channels. Notice the white edge caused by the strong limestone pans which inhibit mangrove growth wherever they exist.

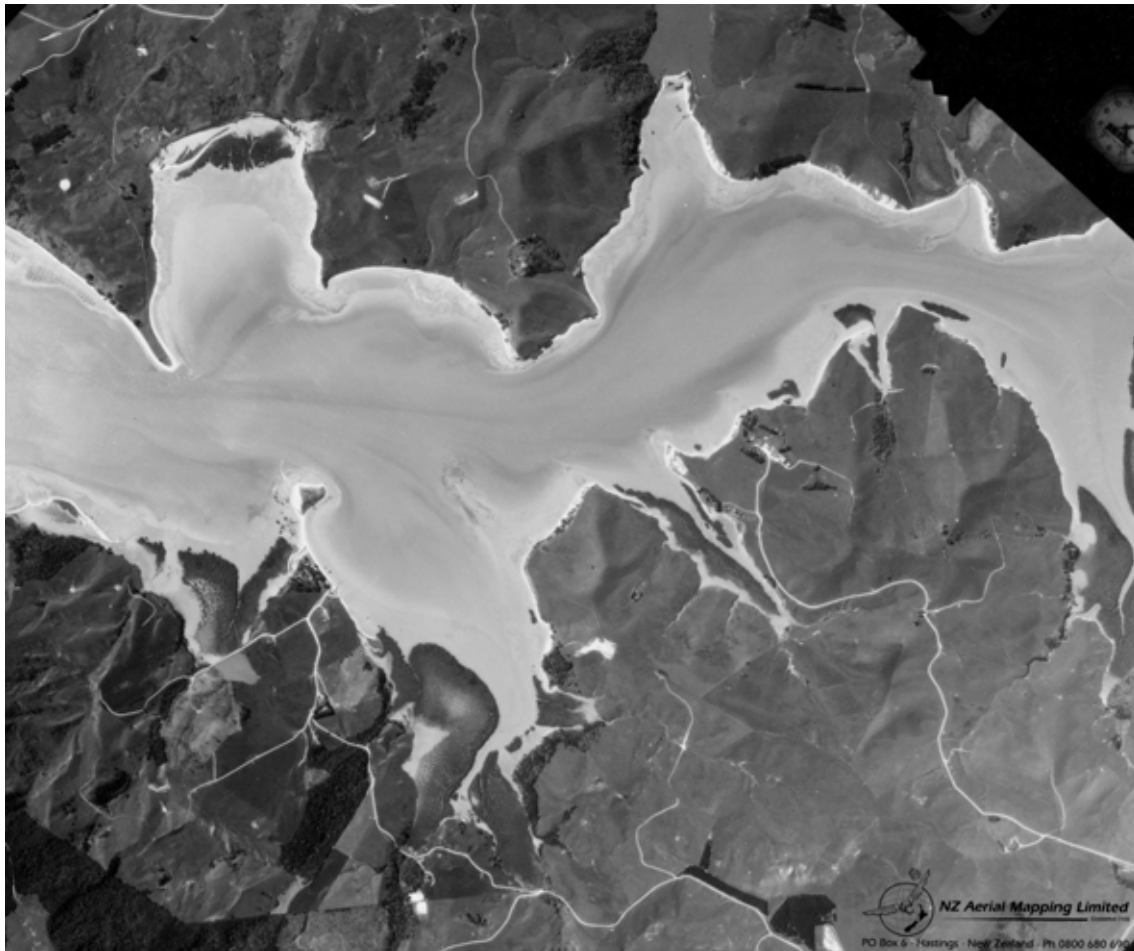
Whakaki River – Hargreaves Family... Aerial Photo – 1982.

The extent of the mangroves is essentially unchanged. The few existing clumps remain protected by channels between the clumps and the pasture.

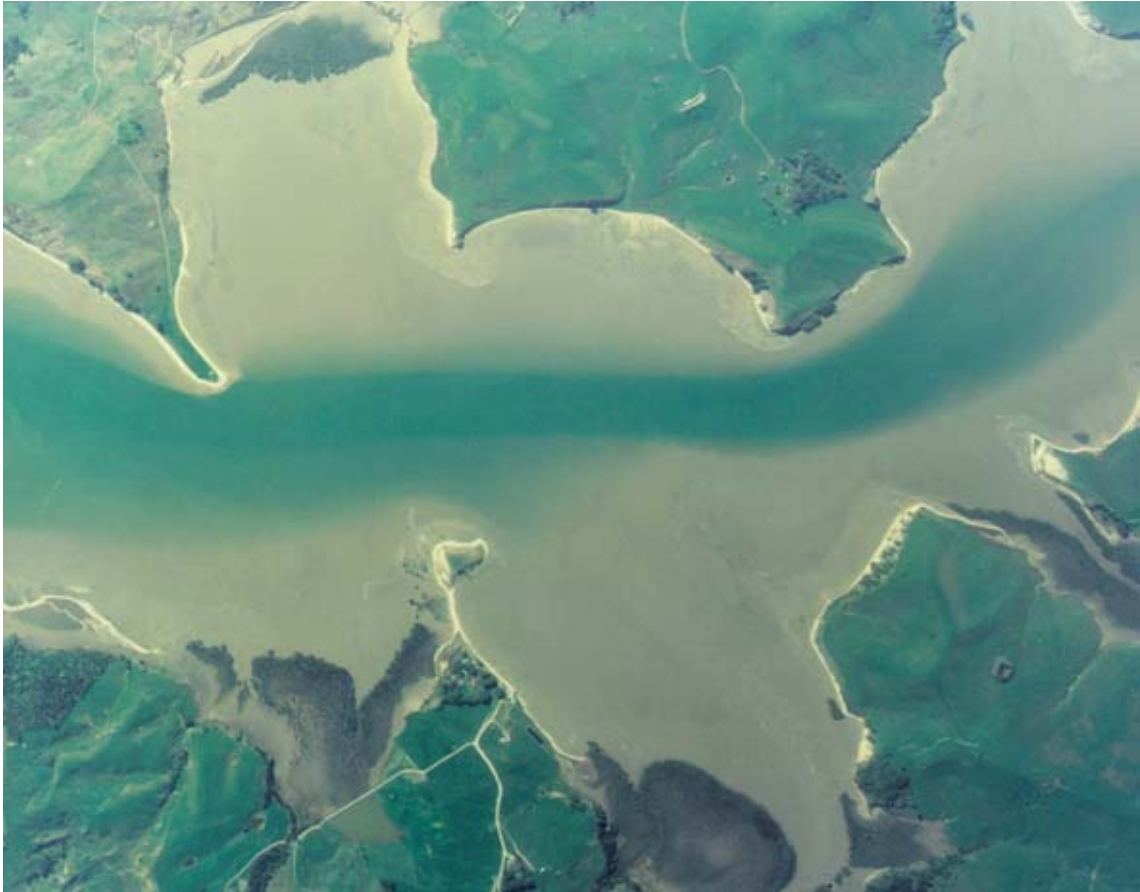
Whakaki River – Hargreaves Family... Aerial Photo – July 1993

Again, virtually tree for tree, the mangrove beds remain unchanged.

If run-off and nutrients were the prime cause then one would expect there to have been some impact on the mangroves in this series of bays. But there have been no causeways built, the channels flush well. The estuaries remain controlled by the ongoing access by cattle, which are not denied access by cliffs, regrowth, or fences.

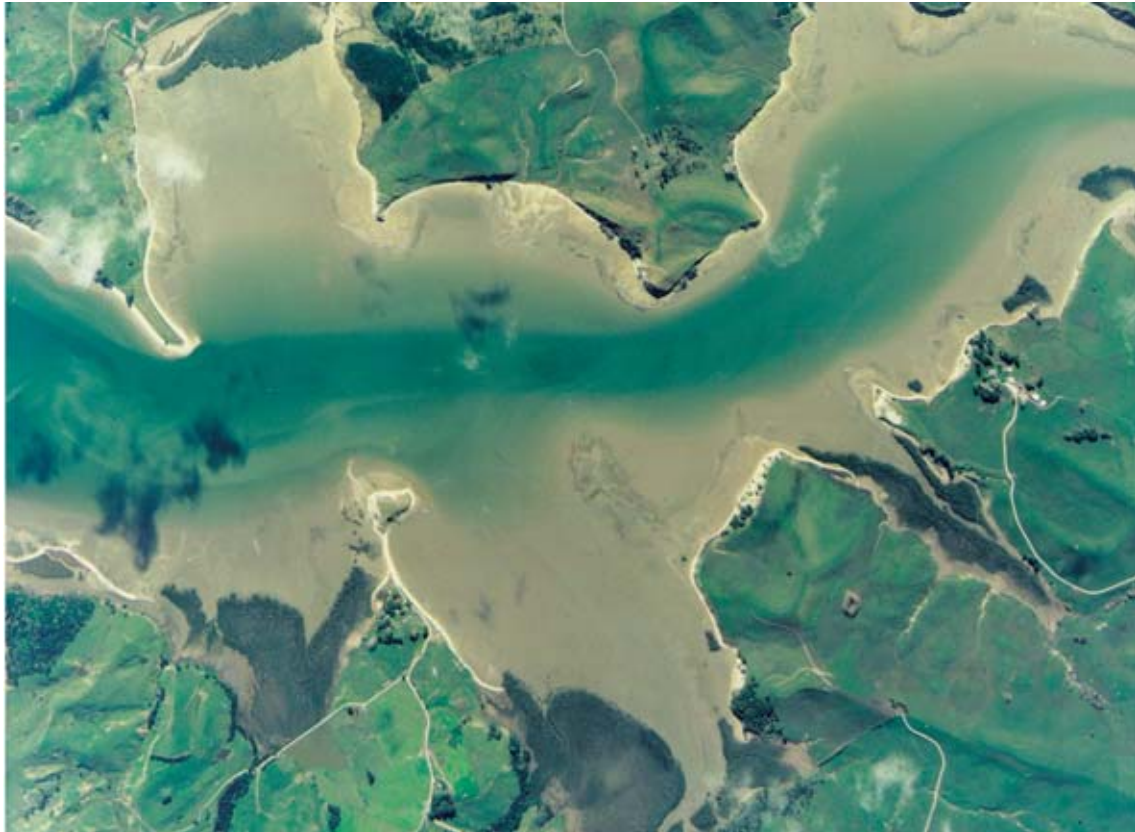
Whakaki River – Hargreaves Family... Aerial Photo – August 2002

The dark patches in the main river flow are clouds, not new mangrove beds. There is little if any invasion of new territory around the edges of the river even though the pasture continues to flow directly to the water's edge. However, there is some intensification of the old existing beds and this may reflect aerial topdressing drift. The limestone pans are clearly evident in this photograph. Channels continue to protect most of the old beds from grazing cattle. If sediment flow was the sole explanation of mangrove spread – or even an important factor – these edges would be full of mangroves. They are not. The dynamics are complex.

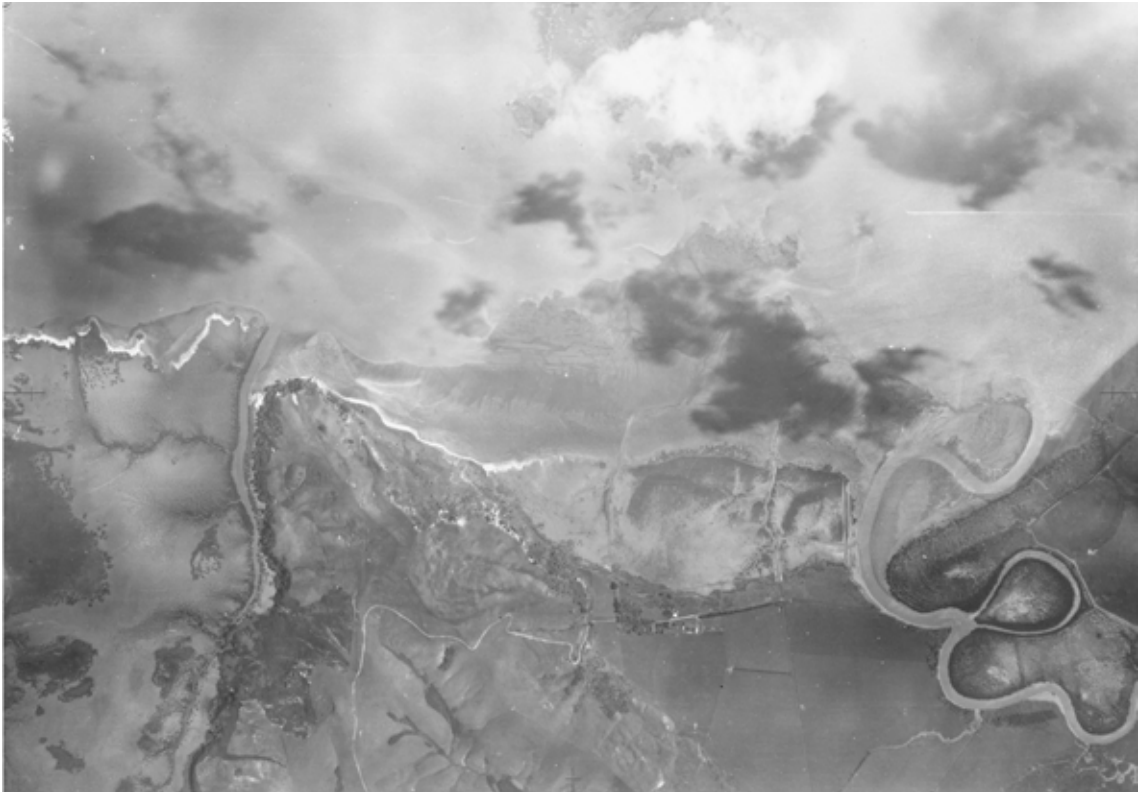
Aerial Photo – April 1941

There are few mangroves on the West-facing bay. The old beds in the estuaries are protected from grazing cattle by channels. The pasture flows to the water's edge. The dark patches over the water are clouds.

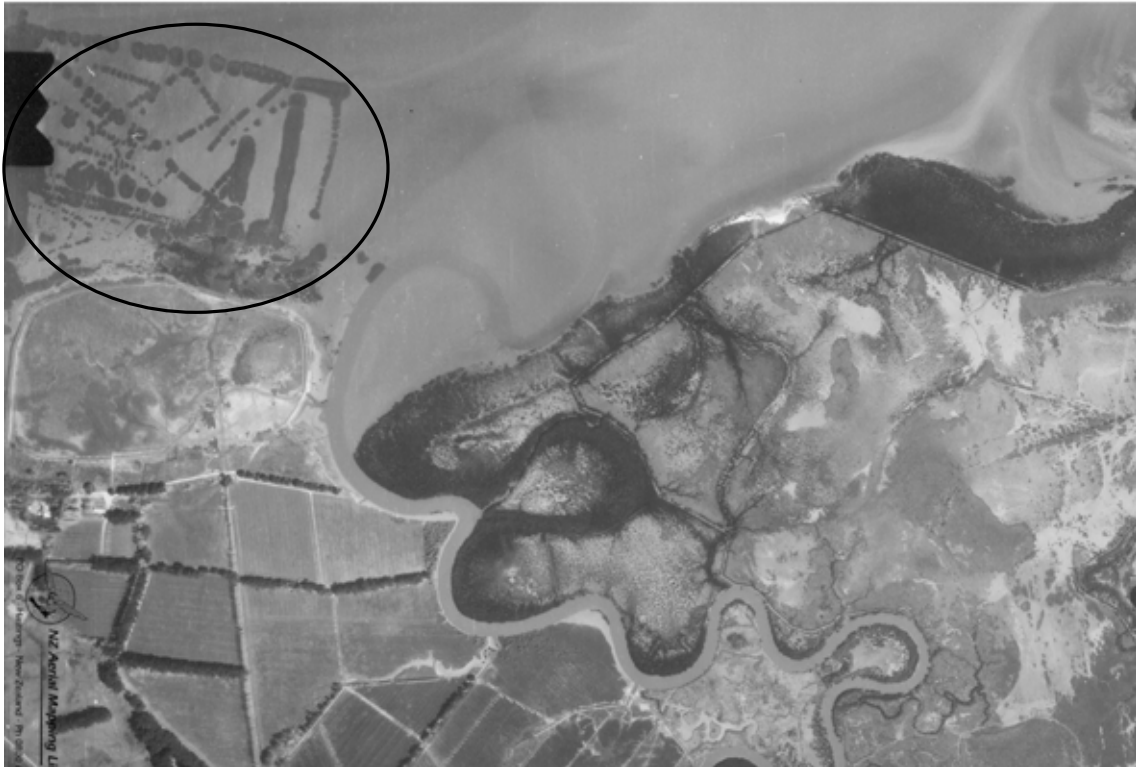
Araparera Point – Spartina Grass and Mangroves... Aerial Photo – September 1982

Evidently Spartina grass was planted in the rectangle (Circled) to control erosion of the area behind it which has been reclaimed. While the mangroves to the centre and right of the picture remain essentially unchanged over the 41 year interval, the spartina beds are flourishing, and mangroves may already be appearing. If anything, changes in land use and planting should be reducing sediment and nutrient run-off during this and subsequent periods.

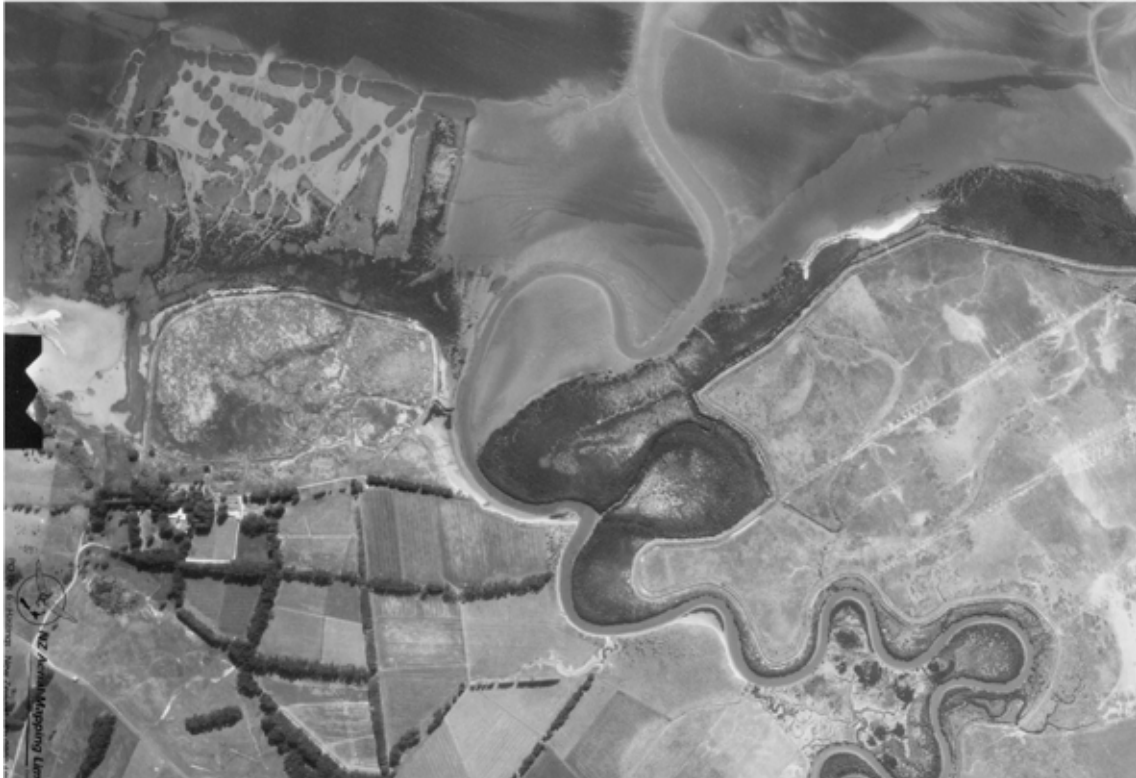
Araparera Point – Spartina Grass and Mangroves... Aerial Photo – February 1992

The change is remarkable. The mangroves have rapidly invaded the beds behind the Spartina grass and have begun to invade the Spartina enclave. The mangroves to the centre and centre right are becoming more dense and gradually infilling any clear areas, except where channels protect them.

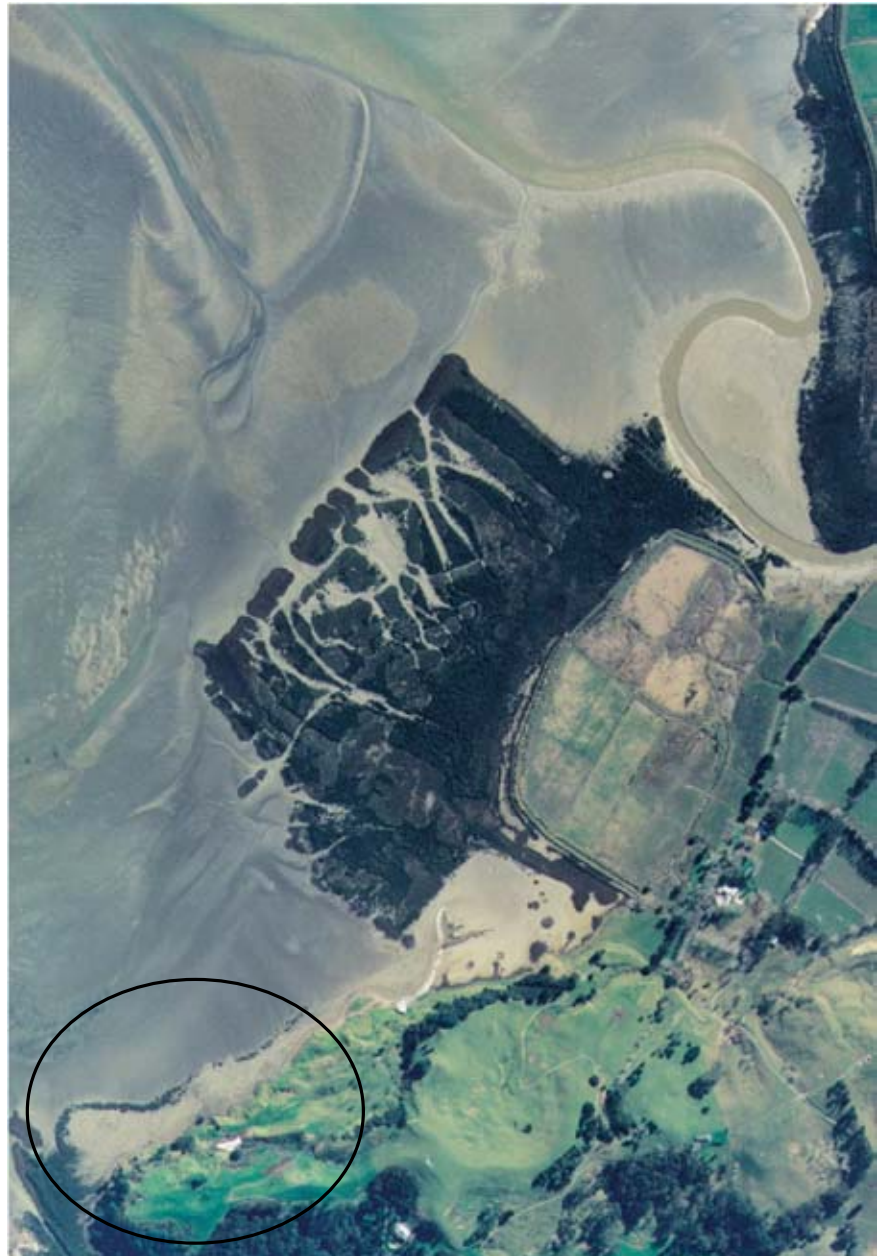
Araparera Point – Spartina Grass and Mangroves... Aerial Photo – August 1999.

The intensification of the mangroves to the east is now near complete but channels continue to prevent any spread. However, the Spartina bed is now totally converted to mangroves which are now spreading to the west and back to the south, hugging the reclaimed areas. The invasion of the clear sandy area and the beach strip is well underway. (Circled) This photo is dated 1999, and visual inspection of these bays and beach show that the invasion has continued and these will soon be dense mangrove beds. Again, changes in land use and extensive planting should have reduced sediment run-off.

Cattle no longer have free access to the water's edge.

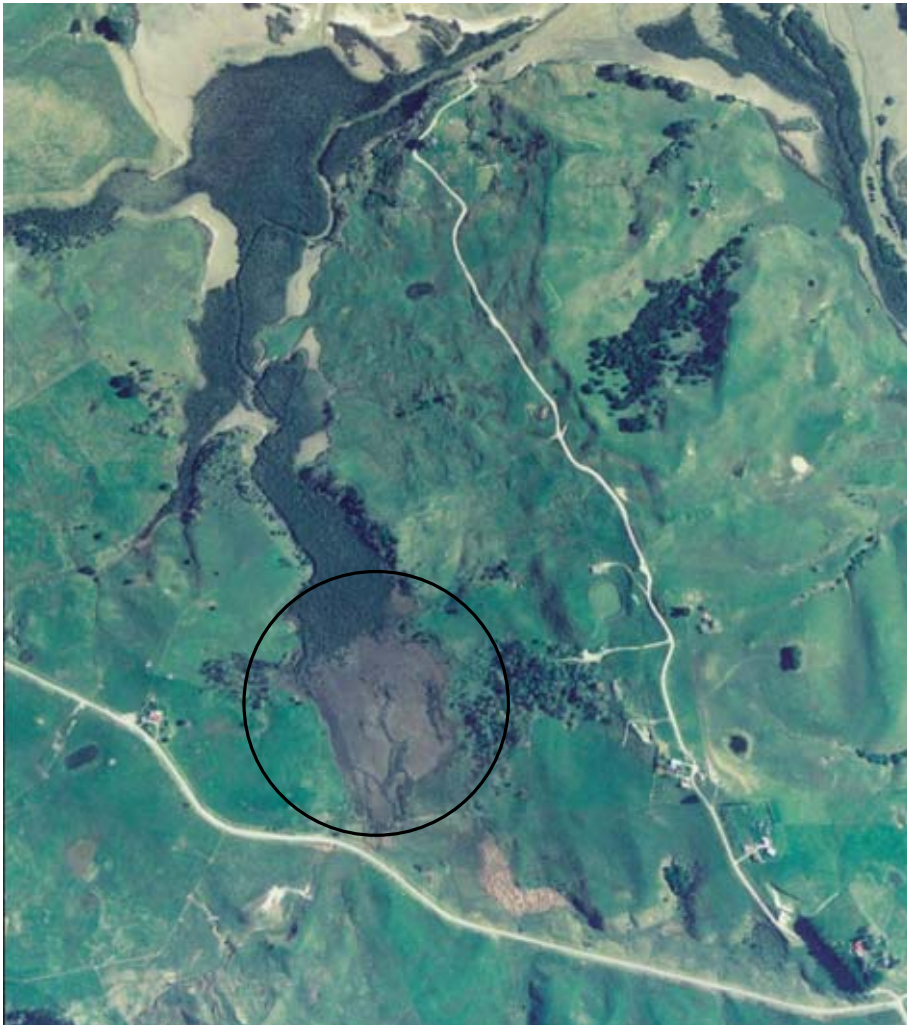
Aerial Photo – 2002

Mangroves have invaded this estuary right to the headwaters. The occupation is complete and now the mangroves at the headwaters have died and the area is rapidly turning to solid land on which cattle once more are starting to graze. This further reduces the flushing effect and presumably this reverse invasion (of dead mangroves into living areas) will continue so that what was an estuary with a free flowing stream will soon be a reclaimed valley.
